FINAL COMMITTEE REPORT

THE DESIGN, DEVELOPMENT & CERTIFICATION OF THE **BOEING 737 MAX**

SEPTEMBER 2020

BY MAJORITY STAFF OF THE COMMITTEE ON TRANSPORTATION AND INFRASTRUCTURE

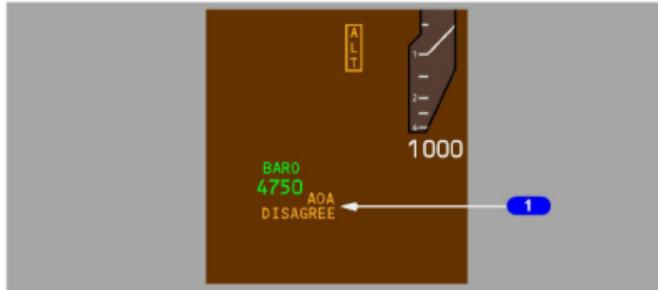
PFD Annunciations and Alerts Angle of Attack (AOA) Disagree Alert

1 AOA Disagree Alert (amber)

Indicates the Captain’s (left) and First Officer’s (right) angle of attack values disagree by more than 10 degrees for more than 10 continuous seconds.
