# FINAL COMMITTEE REPORT

## THE DESIGN, DEVELOPMENT & CERTIFICATION OF THE **BOEING 737 MAX**

**SEPTEMBER 2020**

BY MAJORITY STAFF OF THE COMMITTEE ON TRANSPORTATION AND INFRASTRUCTURE

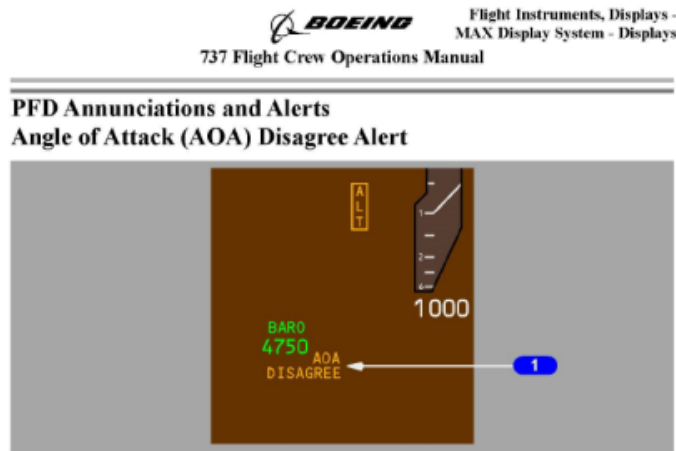
#### 1 AOA Disagree Alert (amber)

Specifically, the FCOM Boeing delivered to Lion Air continued to show pilots an image of a functioning AOA Disagree alert, and assured them that the alert, “Indicates the Captain’s (left) and First Officer’s (right) angle of attack values disagree by more than 10 degrees for more than 10 continuous seconds.”<sup>779</sup>

Indicates the Captain’s (left) and First Officer’s (right) angle of attack values disagree by more than 10 degrees for more than 10 continuous seconds.
