# FINAL COMMITTEE REPORT

## THE DESIGN, DEVELOPMENT & CERTIFICATION OF THE **BOEING 737 MAX**

**SEPTEMBER 2020**

BY MAJORITY STAFF OF THE COMMITTEE ON TRANSPORTATION AND INFRASTRUCTURE

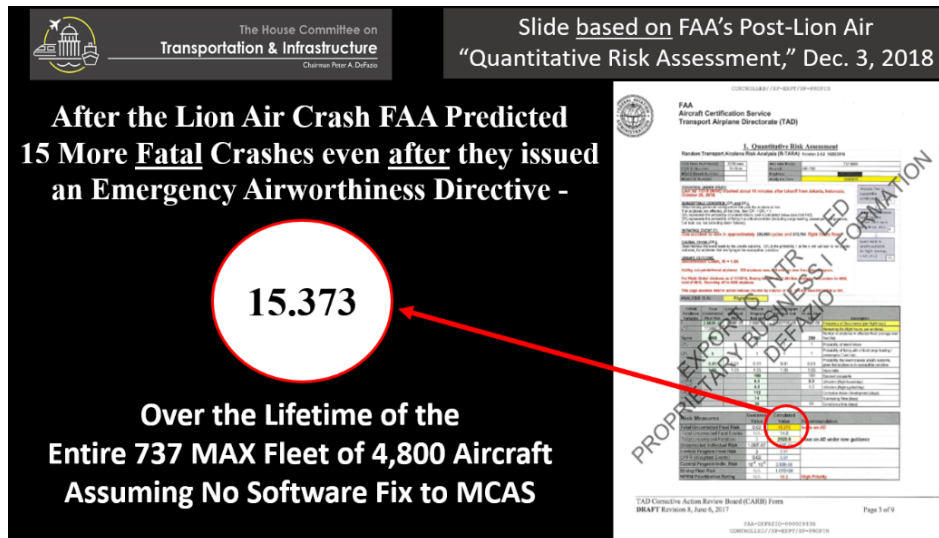
Nevertheless, the results of the TARAM analysis indicated that even with the FAA's Emergency AD, but without a fix to MCAS,

there could be more than 15 fatal 737 MAX crashes over the estimated 30-year lifetime of the fleet, then estimated to be 4,800 aircraft, resulting in over 2,900 deaths.<sup>1242</sup> Statistically this meant that the FAA was predicting there would be one fatal 737 MAX accident every two years for the next 30 years—or one fatal accident roughly every 24 months for the next 360 months. The FAA assumed that these potential future crashes would result in the loss of life for everyone on board the planes and some bystanders on the ground as well.<sup>1243</sup> However, they also estimated that Boeing would
