FINAL COMMITTEE REPORT

THE DESIGN, DEVELOPMENT & CERTIFICATION OF THE **BOEING 737 MAX**

SEPTEMBER 2020

BY MAJORITY STAFF OF THE COMMITTEE ON TRANSPORTATION AND INFRASTRUCTURE

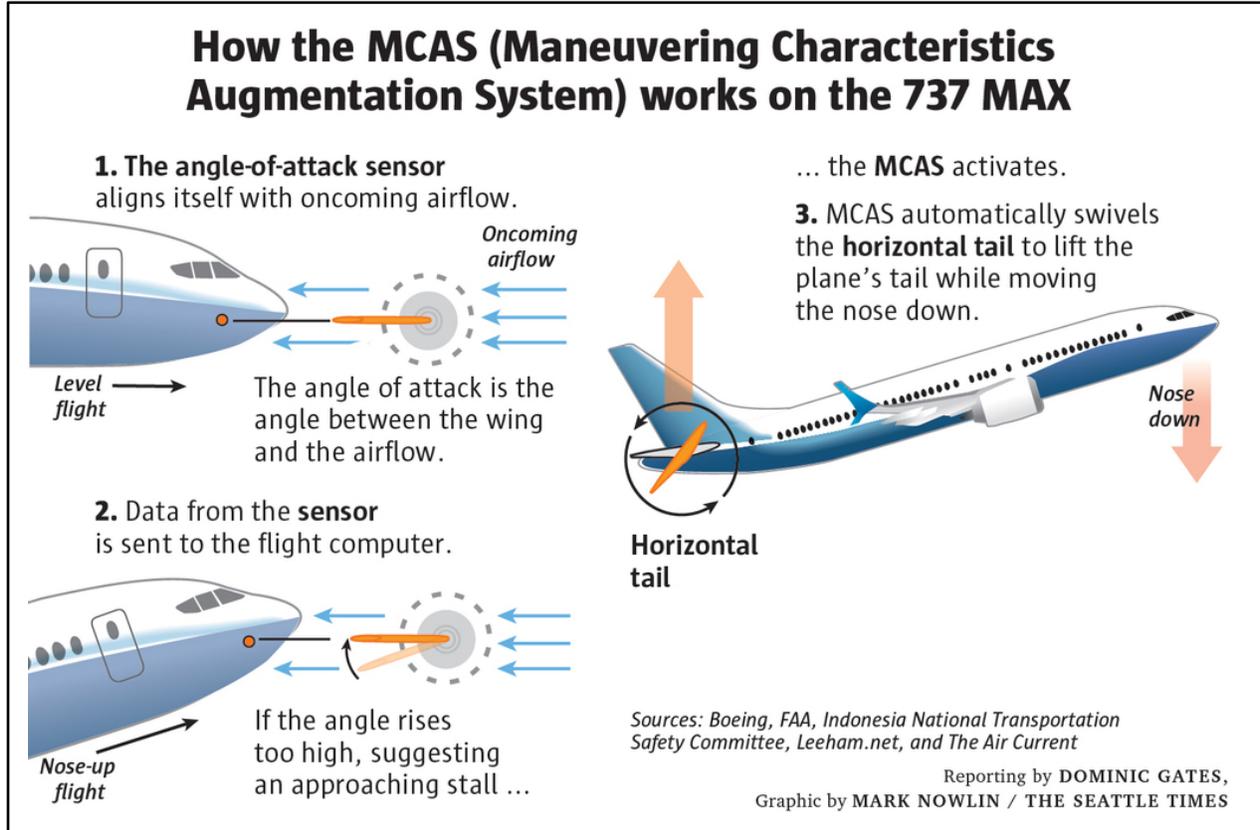
the FAA mandates that airplanes handle this maneuver with a smooth transition.⁵³³ To address this, Boeing’s engineers initially considered adding small metal vanes known as vortex generators on the wings.⁵³⁴ This proposed fix did not prove to be satisfactory to address the issue, however. Ultimately, Boeing decided to add the Maneuvering Characteristics Augmentation System (MCAS) to the 737 MAX to help the aircraft compensate for those flight conditions.⁵³⁵

As described in more detail above, MCAS is an automated system designed to activate if and when the 737 MAX reached, among other things, a high AOA. In such an event, MCAS would move the plane’s horizontal stabilizer to push the plane’s nose in a downward direction, to reduce

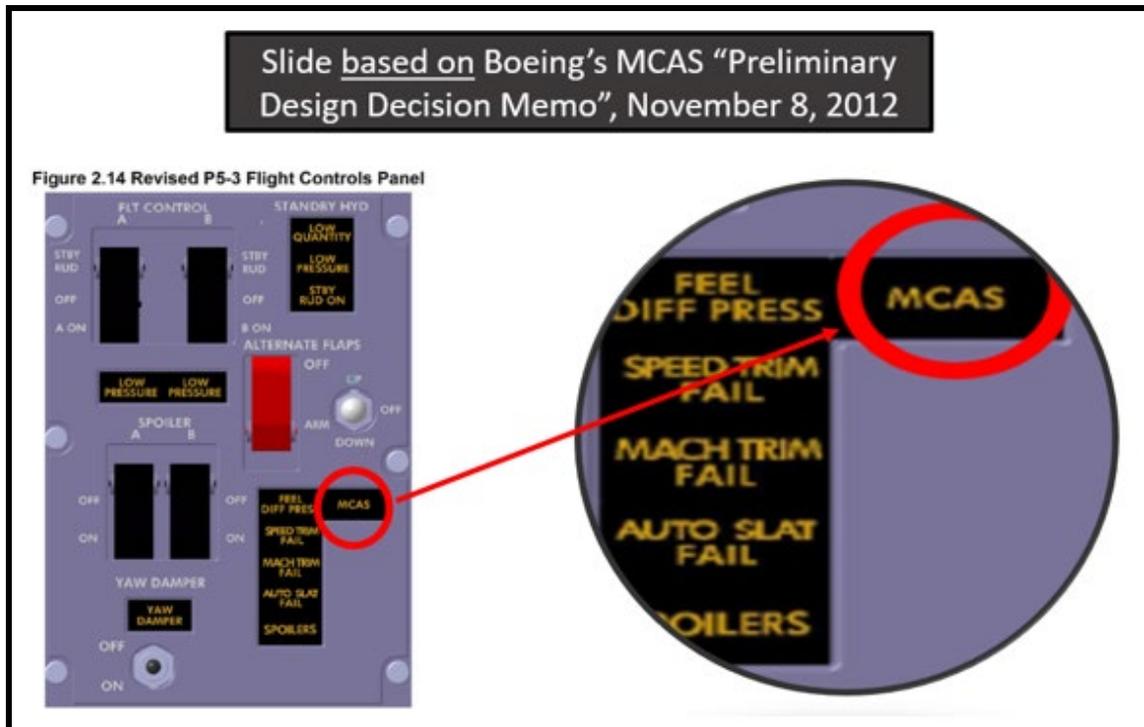
okay to not annunciate it, after all, what would the crew do? Should it be annunciated with the existing SPEED TRIM FAIL light,” the email said. But it added, “The speed trim system is not all that reliable.”⁵⁴⁵

The notion that MCAS was simply an extension of the speed trim system was a central tenet from Boeing during its certification. Technically, MCAS is part of the speed trim system.⁵⁴⁶ However, many aviation experts have expressed concerns that this narrow definition was a strategy to muddy the waters around MCAS so that Boeing could claim that MCAS was not new or novel and therefore should not be subjected to greater scrutiny during certification. Greg Travis, a software expert and private pilot, published one of the first detailed articles on MCAS in the Institute of Electrical and Electronics Engineers' (IEEE's) magazine *SPECTRUM* in April 2019.⁵⁴⁷ According to Travis, Boeing's efforts to describe MCAS as simply an extension of the MAX's "speed trim system" was an effort to "give shade and cover to the notion that MCAS in the 737 MAX was not new."⁵⁴⁸

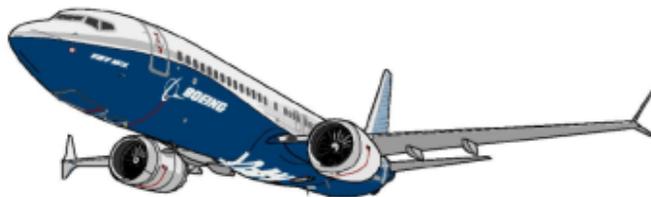
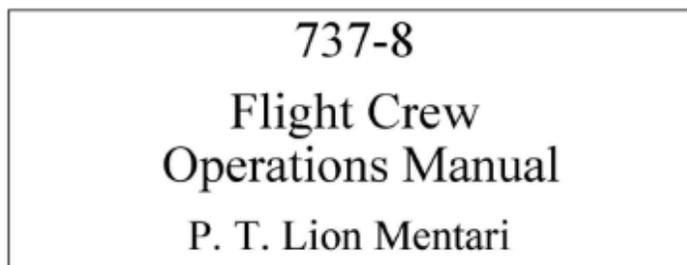
Document Number D6-27370-MAX-MLI
Revision Number: 4
Revision Date: August 16, 2018

Boeing considered notifying airlines who were flying the 737 MAX about the defective AOA Disagree alert, and even prepared a Fleet Team Digest on the issue.⁷⁷³ These digests provide “in-service issues,” including economic and safety-related information to Boeing’s customers.⁷⁷⁴ Ultimately, however, Boeing never sent the digest,⁷⁷⁵ and Boeing’s customers and MAX pilots remained unaware of the inoperable AOA Disagree alerts until after the Lion Air crash.

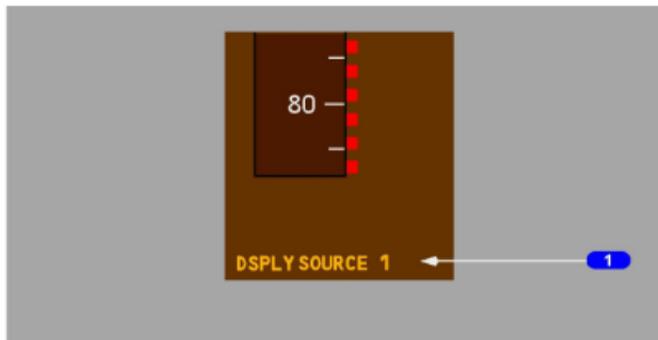
1 Display System Annunciations

Indicates the Captain’s (left) and First Officer’s (right) angle of attack values disagree by more than 10 degrees for more than 10 continuous seconds.

When there is a problem with the DPC display system, one of the following indications will appear in the lower left corner of the primary flight display:
DSPLY SOURCE 1 or 2 (amber) – DPC 1 has failed or DPC 2 has failed.
