# FINAL COMMITTEE REPORT

## THE DESIGN, DEVELOPMENT & CERTIFICATION OF THE **BOEING 737 MAX**

**SEPTEMBER 2020**

BY MAJORITY STAFF OF THE COMMITTEE ON TRANSPORTATION AND INFRASTRUCTURE

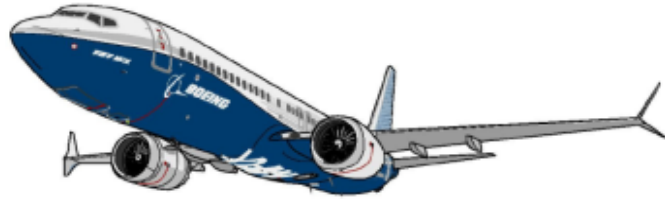
#### 737-8 Flight Crew Operations Manual P. T. Lion Mentari

Boeing considered notifying airlines who were flying the 737 MAX about the defective AOA Disagree alert, and even prepared a Fleet Team Digest on the issue.<sup>773</sup> These digests provide “in-service issues,” including economic and safety-related information to Boeing’s customers.<sup>774</sup> Ultimately, however, Boeing never sent the digest,<sup>775</sup> and Boeing’s customers and MAX pilots remained unaware of the inoperable AOA Disagree alerts until after the Lion Air crash.
