Boeing Records (First Set)

Configuration Development/Changes

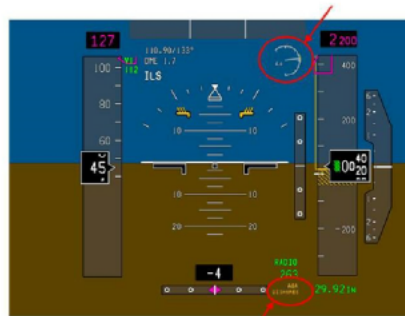
Situation

- MAX - AOA DISAGREE message was erroneously tied to the AOA Gauge option. (RCI Coding error)
- Message added to 737 NG in 2006 - customer request due to an air turn back event due to a damaged AOA vane that caused various seemingly unrelated flight deck effects to appear.

Condition: The AOA DISAGREE alert indicates the left and right angle of attack vanes disagree.
